Check list for site visits where there are fitting or screed issues.

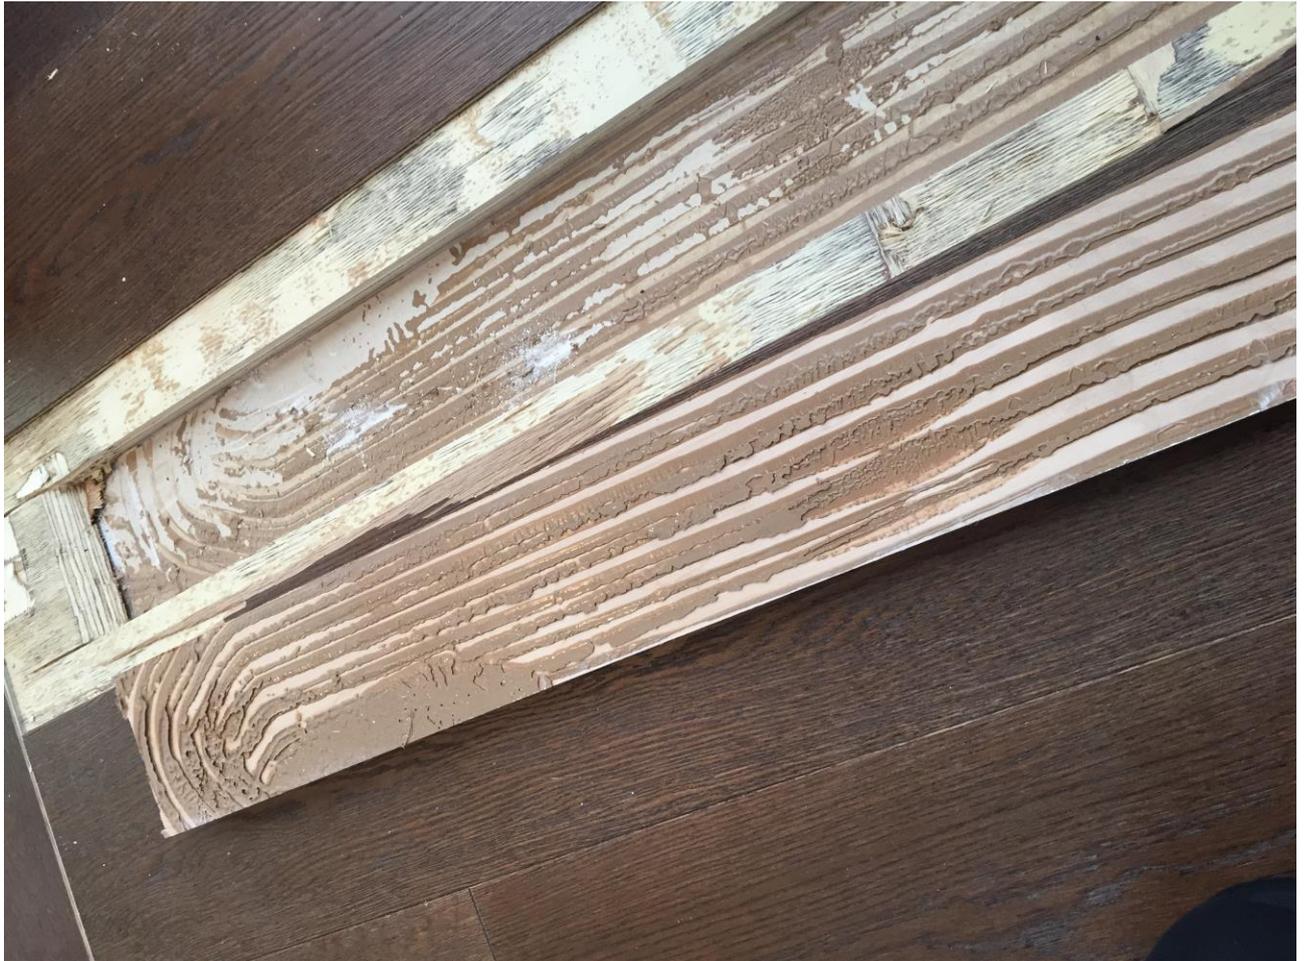
The boards below were taken up in one such scenario where the incorrect adhesive was used and not applied properly. It was found that the laitance had not been removed correctly either.

BS 8204 states that you must have a minimum adhesive transference of 75% of the surface area of the plank. In addition, they have used the wrong size trowel and the spacing is too large and not enough adhesive has been applied. Also, the top board in the picture shows large patches of white laitance stuck to the adhesive which means that the laitance has not been removed properly and it is this that has debonded from the screed.

To exacerbate the situation these apartments have underfloor heating. When gluing over underfloor heating it is imperative that you get 100% transference of adhesive between the board and the substrate otherwise you not only get hot spots but also an imbalance of moisture in the backing board which can cause the adhesive within the board to stress and delaminate. When this happens the boards get partially cooked which is not good for the long term.
